Manhole Inspection Summary

Manhole # S29K__006MH

Location Address: **MLK Blvd**

Cross Street: **McHenry St**

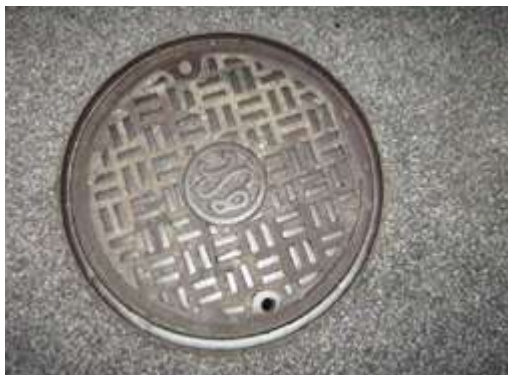
Miscellaneous

mh cover

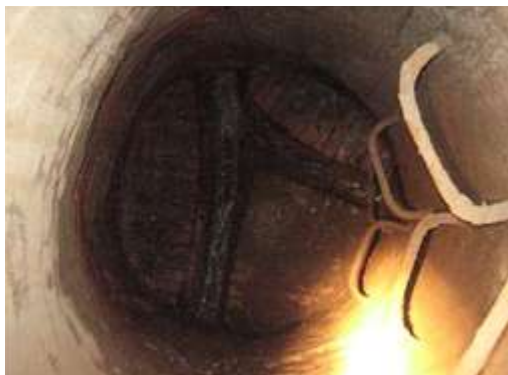
Defect 1

☒ **Corroded**

corroded steps

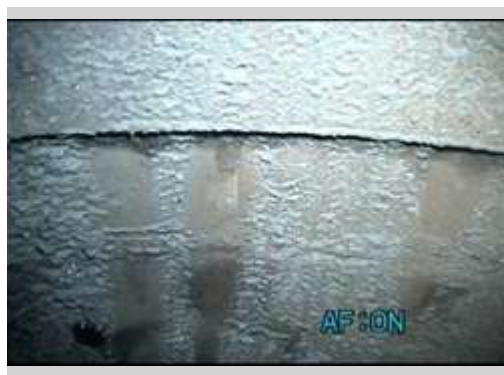
Defect 3

Infiltration: ☐ None ☐ Joint ☐ Cracks ☐ Mortar ☐ Roots ☒ **Wall**

infiltration at chimney joint

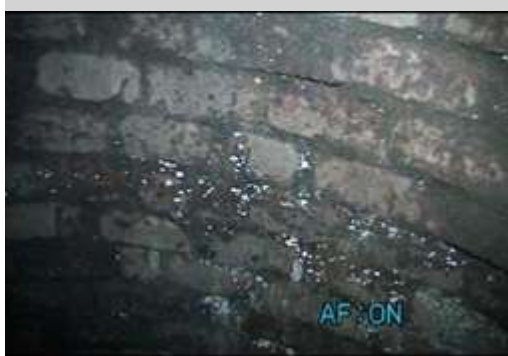
Defect 2

Infiltration: ☐ None ☐ Joint ☐ Cracks ☒ **Mortar** ☐ Roots ☒ **Wall**

infiltration and deposits on corbel
wall/mortar

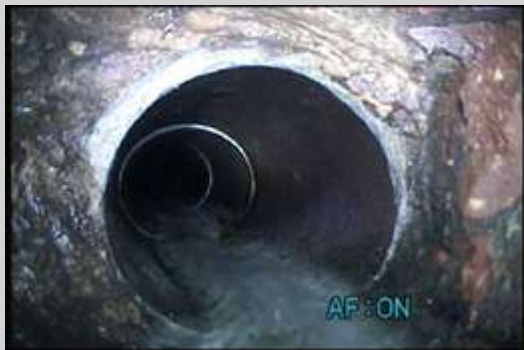
12 O'Clock Outflow

Pipe Height: **8.4** (in.) Rod and Bar (Angled)
Pipe Material: **Clay** ☐ Pipe Lined
Invert Depth: **9.78** (ft.) Flow Characteristics: **Fast**
Deposits: ☒ None ☐ Mud ☐ Sludge ☐ Debris ☐ Grease
Silt Depth: **0** (in.) Deposits Extent:
Infiltration: **None** Pipe Seal Cond: **Sound**

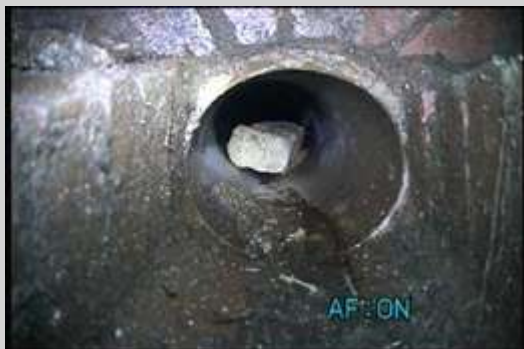
4 O'Clock Inflow

Pipe Height: **6** (in.) Rod and Bar (Angled)
Pipe Material: **Clay** ☐ Pipe Lined
Invert Depth: **9.24** (ft.) Flow Characteristics: **Slow**
Deposits: ☐ None ☐ Mud ☐ Sludge ☒ Debris ☐ Grease
Silt Depth: **0** (in.) Deposits Extent: **Light**
Infiltration: **None** Pipe Seal Cond: **Sound**

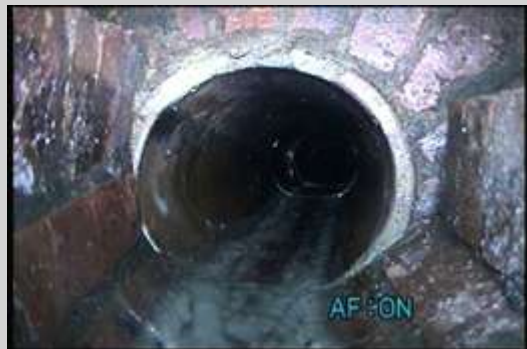
7 O'Clock Inflow

Deposits: ☒ None ☐ Mud ☐ Sludge ☐ Debris ☐ Grease

Infiltration: **None** Pipe Seal Cond: **Sound**
